# Durability of building fabric components and ventilation systems in passive houses

Wolfgang Feist • Rainer Pfluger • Wolfgang Hasper

Received: 16 November 2018 / Accepted: 6 February 2019 / Published online: 9 March 2019 © The Author(s) 2019

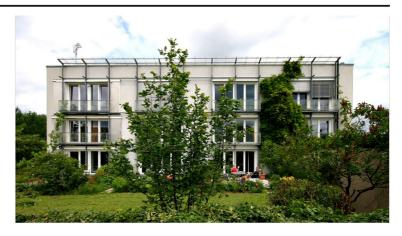
Fig. 1 First regularly occupied passive house; row of four dwellings designed by architects Bott/Ridder/Westermeyer placed in Darmstadt Kranichstein/Germany/cool temperate climate (after Troll and Pfaffen 1964) (photo: authors)

The results of these developments were used within the design of the first occupied passive demonstration building, a three-storey, four-unit terrace house by architects Prof. Bott/Ridder/Westermeyer (Bott 2014). The four units were built 1990/1991 and completed in October 1991 before four families moved in (Fig. 1); there are now 27 years of user experience and monitoring protocols. The research documented here looks into the service life of all systems.

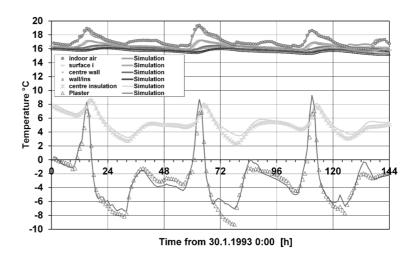
Fig. 2 Comparison of monitoring data (symbols) with whole building thermal simulation (lines); example west-facing external wall in the third floor and indoor temperatures in the adjacent room (diagram: authors)

- Measurements in the building and simulation results of temperature profiles coincide within 0.2 K and are within the accuracy of the sensors.
- The thermal simulation model based on Fourier's equation, temperature dependent convective film coefficients and a radiation model give reliable results using the known geometry and the standard material properties (without fitting parametres).
- The buildings perform within the measurement accuracy, reproducing the extraordinarily low heat flows from the preliminary simulation done for the design.

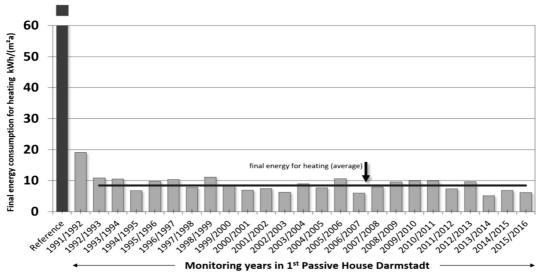
Fig. 3 Monitoring results of final energy consumption for heating; natural gas metering for the total of all four dwelling units; heating and domestic hot water (dhw) discriminated by heat metres; reference: German ordinance 2016; data from (Feist et al. 2016b)

Figure 3 shows that the heating energy consumption has remained stable at an average of 8.4 kWh/(m<sup>2</sup>a); this is measured final energy (natural gas) used in the central heating system for all four dwellings in the row, thus including all losses of the space heating system (losses of the furnace and also all distribution losses). This is even less than calculated by the preceding simulation and the design value of 11 kWh/(m<sup>2</sup>a) (PHPP 2016). For comparison, average heating energy consumption in comparable German dwellings in 2016 was reported to be  $138 \text{ kWh/(m}^2\text{a})$  (Techem 2017); the actual 2016 German ordinance for new buildings of this type requires still just some 60 kWh/(m<sup>2</sup>a). The monitored final energy consumption for heating in the pilot project is thus 14% of the average consumption of new buildings in the same category. The diagram shows variations with different winter weather conditions but no long-term trend: The overall efficiency of the building is thus not deteriorating, nor are there palpable changes in user behaviour.

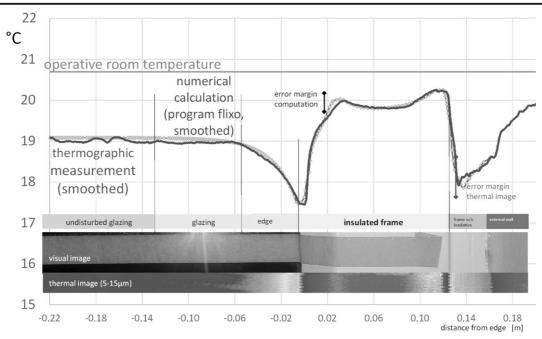
Fig. 11 Temperature profile for the interior window's surface; bold: thermographic measurement (shown in a grey scale in the bottom-most thermal image excerpt); grey symbols: 2D heat flow calculation, result:  $\Psi_g = 0.03 \text{ W/(mK)}$  (EN 10077) (graphic: authors)

Figure 11 shows the comparison of calculation results (2-D heat flow (EN 10077)) to measurements. Thanks to the insulation panels, the frames have an  $U_f$  value of 0.62 (2) W/(m<sup>2</sup>K). Concerns were voiced about encapsulating the timber within integral foam insulation on both sides, but hygrothermal simulation provided a clear

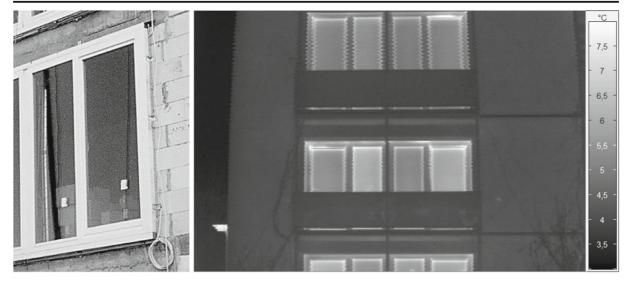
a Construction site photo, 1991: b Thermographic image of the southern façade in 2016: No thermal bridge Installation of a window in front effects are visible around the windows (IR shading from the balcony is visible, as are slight variations in U-values of the glazing and the edge effects of the aluminium spacers). At the bottom left of the image: the exhaust air outlet

Fig. 12 Thermal bridge-free window installation in 1991 (a cf. the frame bracket on the wall as a support) and b infrared image from 2016 (photo and IR image: authors)

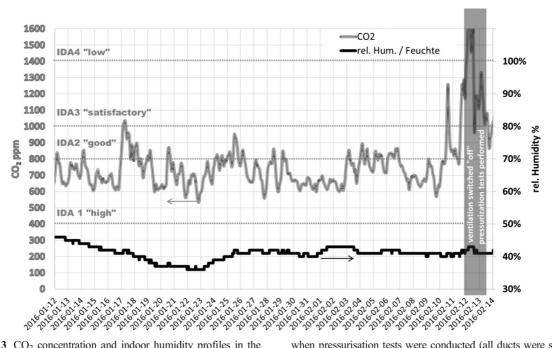
Fig. 13 CO<sub>2</sub> concentration and indoor humidity profiles in the third floor on the north side of the pilot project. Note the time when the ventilation system was not in operation on 12 and 13 Feb 2016,

when pressurisation tests were conducted (all ducts were sealed, but windows were repeatedly opened for ventilation) (diagram: authors)

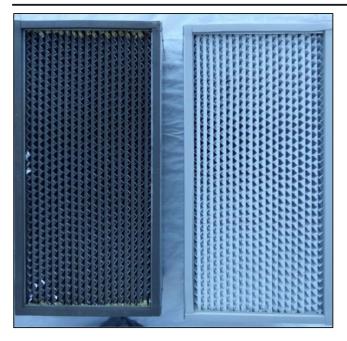
Comparison of F8 filters: Left: old (1 year); right: new; the filters were dry and showed no visible sign of biological activity. Also no elevated levels of radioactivity were detected.

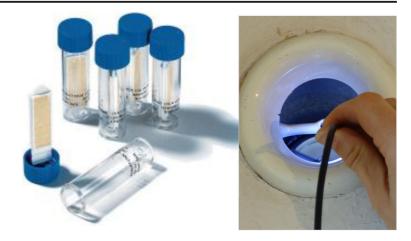
Fig. 17 Swab samples with pads (Merck ENVIROCHECK CONTACT TVC, left), special camera for the inspection of ventilation ducts (Snakecam, right; photos: authors)

Moreover, the duct wall was examined with the help of selvedge samples (impression plates Merck ENVIROCHECK CONTACT TVC). This type of sampling was particularly well suited because the plates can be easily applied to the inner surface of the round channels (Fig. 17).

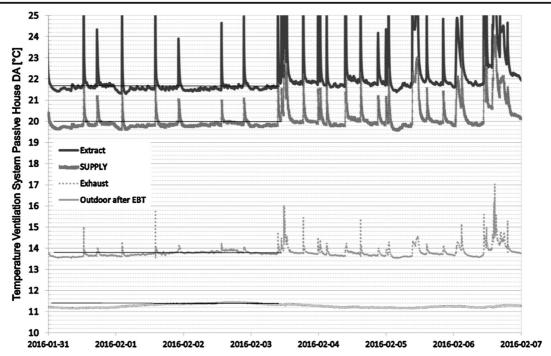
Fig. 19 Temperature profiles of the airflows within the ventilation unit (February 2016). The counter-flow heat exchanger thus has a heat recovery rate of 82 (2)% (in not condensing conditions). This

value has not changed (within measurement tolerance) since first measured in 1991. Temperature peaks are caused by extract air from cooking in the kitchen (diagram: authors)
